Site Walk Observations

DATE: 11/16/2023
 PROJECT: CID Bus Stop and Storefront Lighting Assessment
 SPARKLAB PROJECT #: 23010
 NOTES BY: Quan Viet Nghiem

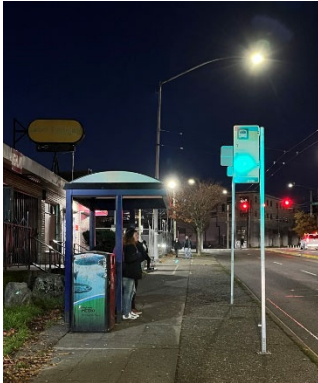
LOCATION	OBSERVATIONS	PHOTOS
1.0	Bus Shelters and Stops	
Rainier and King Bus Stop – West Side	<p>Bus shelter is lit by an adjacent streetlight, pedestrian scale pole. Internal solar downlight is not working.</p> <p>The sides and bench of bus stop have been removed to avoid creating a concealed area behind it. Faces are visible. Bus stop doesn't feel dark but does feel unpleasant due to loitering pedestrians.</p> <p>Light level at grade is 2.1 footcandles, CCT is 5700K.</p>

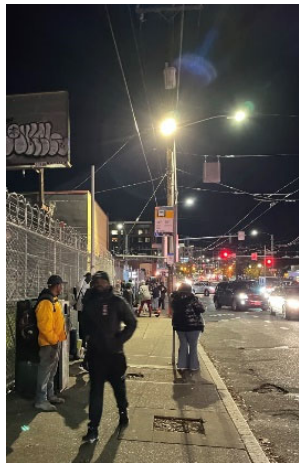
12 th and King Bus Stop – West Side	<p>Unsheltered bus stop is well illuminated by a nearby cobra head streetlight and a flood light intended for adjacent parking lot. There is a pole with no fixture on it here that may have had a fixture on it at some point. Faces are visible, but the location does not feel safe due to loitering pedestrians.</p>

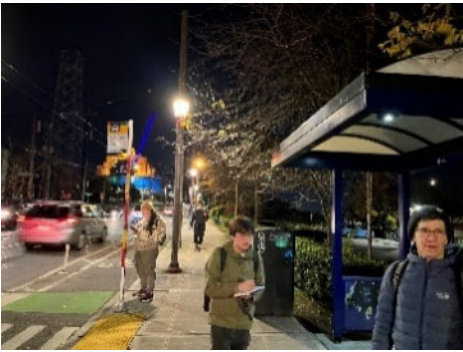
<p>12th and Weller Bus Stop – West Side</p>	<p>Bus stop and shelter is well lit from adjacent cobra head streetlight and King fixture. Shelter includes an integrated downlight. Generally, the stop feels pleasant.</p>

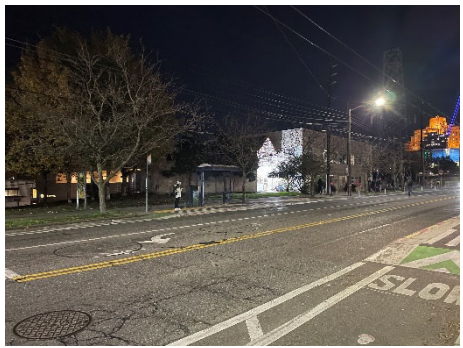
<p>12th and Weller Bus Stop – East Side</p>	<p>Unlike the west side, the bus stop on the East side of the street and shelter is poorly lit. There are no nearby pedestrian pole fixtures and overgrown branches around the shelter block light from nearby cobra head fixtures. The shelter is also devoid of an integrated downlight.</p>

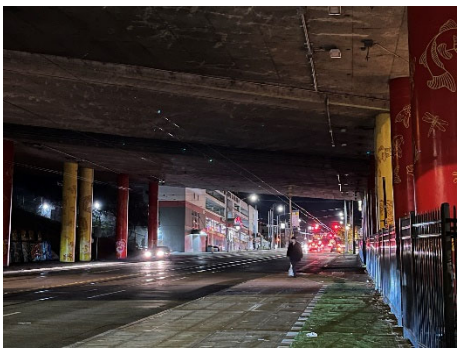
<p>Under freeway, Jackson bus stop</p>	<p>The bus stop sign on Jackson is mounted on a pedestrian streetlight that is not working. Under the freeway, there are multiple flood lights which are supposed to provide light to the sidewalk. None of the light fixtures in the area are working. The light from the roadway fixtures outside of the freeway area slightly help to improve the light level.</p>

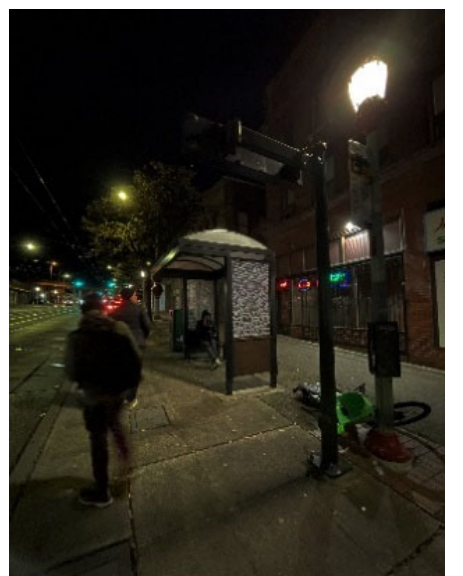
<p>Jackson and Maynard Valley</p>	<p>This stop and shelter are near a King fixture which is also the main light source for it. The fixture is likely located too close to the bus shelter which casts a dark shadow over the shelter. The storefront around it is unlit. The light fixture inside the shelter is also not working. The location does not feel safe due to loitering pedestrians.</p>

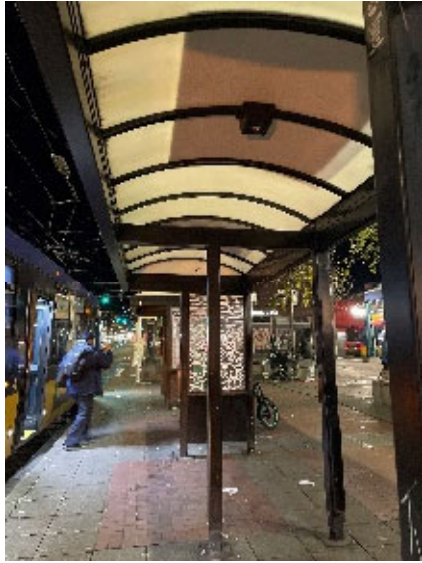
<p>Union Station 5th AVE</p>	<p>This stop and shelter are mainly lit by spill light from Union Station fixtures. The lighting is comfortable and enables clear facial recognition. The integrated downlight in the shelters are no longer working.</p>

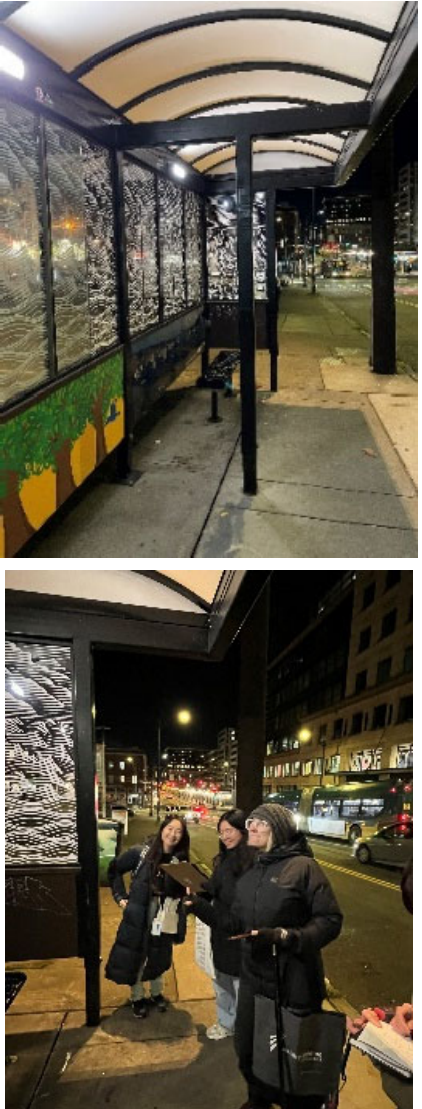
<p>5th AVE and Main St</p>	<p>This bus shelter is very well-lit. The shelter has wired integrated light fixtures which produce diffuse light that enables visual clarity and facial recognition. The light also creates a comfortable, safe, and warm atmosphere around the bus stop.</p> <p>Light level at grade is 2.8 footcandles, CCT is 3850K.</p>

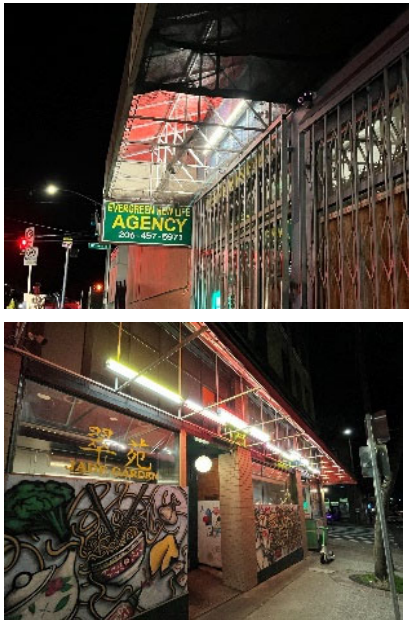
2.0	Storefronts and Streetlighting	
Evergreen New Life Agency & Jade Garden	<p>Canopy lighting from strip lights is a common lighting method in the district. Often wall-mounted, linear fixtures provide sufficient lighting for both signage lighting and facial recognition. They diffusely backlight signage canopies and provide downlight for the sidewalk, and often front-light for the building storefront.</p> <p>Overall, this method of lighting is multipurpose.</p>

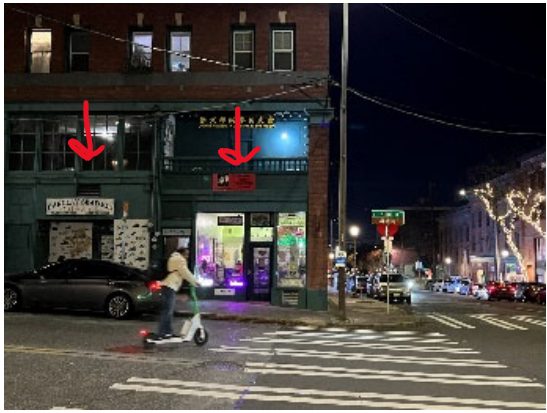
King ST Barclay Seafood and the store on the right	<p>Storefront lighting contributes to the pedestrian experience. For example, the BarClay Seafood store (left arrow) is unlit in contrast to the store next door (right arrow), which helps provide some lighting for the sidewalk. Roadway light contributes to both storefront areas.</p>

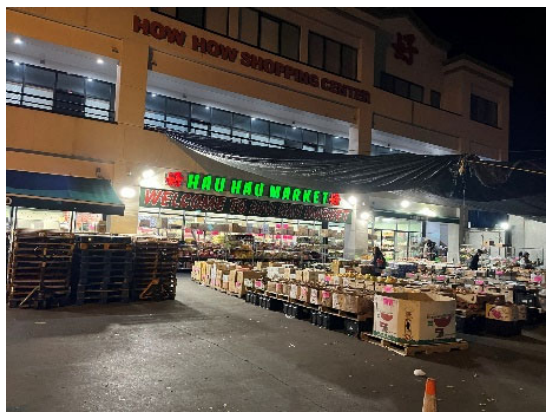
Hau Hau Market	<p>Hau Hau market currently is light enough for facial recognition and wayfinding; however, the flood light could be replaced with a more comfortable and less glary product. They may be in the process of obtaining funding to cover the produce area with a more permanent solution, which would provide opportunity to mount lighting in a way that is more visually comfortable and located closer to the sidewalk.</p>

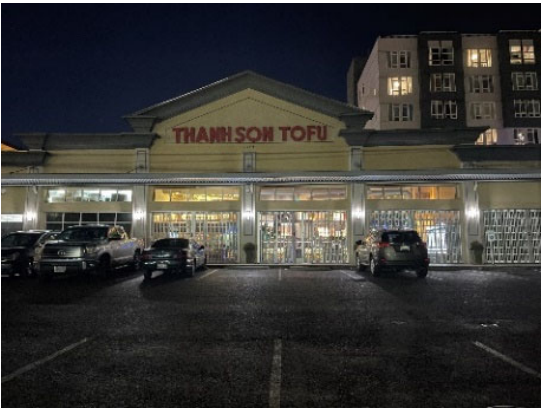
<p>Thanh Son Tofu</p>	<p>Thanh Son tofu facility is very well-lit. There is sufficient parking lot lighting for facial recognition and wayfinding. The wall sconces are visually pleasing and not glary. Furthermore, leaving their interior light on also contributes to the perception of safety of the area.</p>

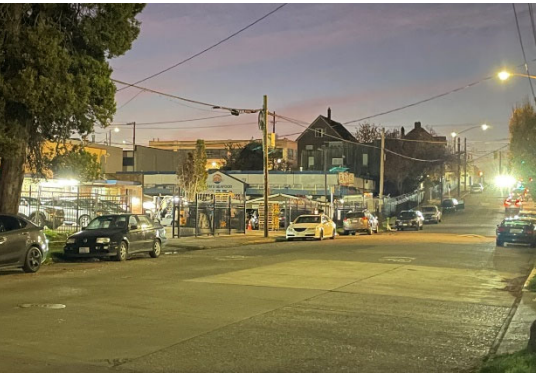
<p>Lam Market</p>	<p>The Lam Market, an actively used area at night, is poorly lit. The parking area is harshly lit by a floodlight and roadway light spill. This retail destination has the potential to contribute to street presence in the surrounding area. In contrast, their receiving warehouse is highly lit by high-glare flood lights.</p>

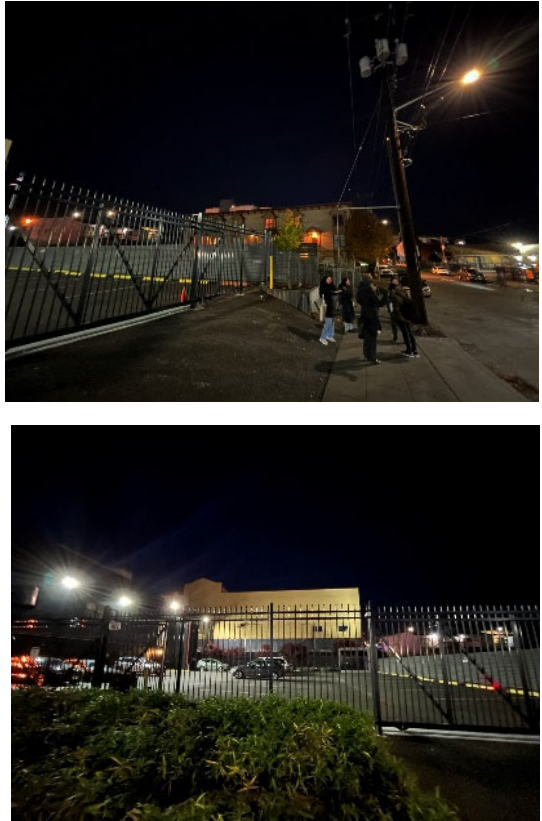
<p>Nisei Veterans Memorial Wall area</p>	<p>The area is high contrast. With the new park nearby improved lighting is expected. The building next to the memorial has high-glare fixtures.</p> <p>The Nisei Veterans memorial wall, an area with existing lighting that is not turned on (or no longer works) feels dark, potentially intentionally so. Wall-mounted floodlights on the nearby building contribute light to the area and create aggressive glare. Pole mounted lighting in the parking lot would be a more comfortable and welcoming solution.</p>

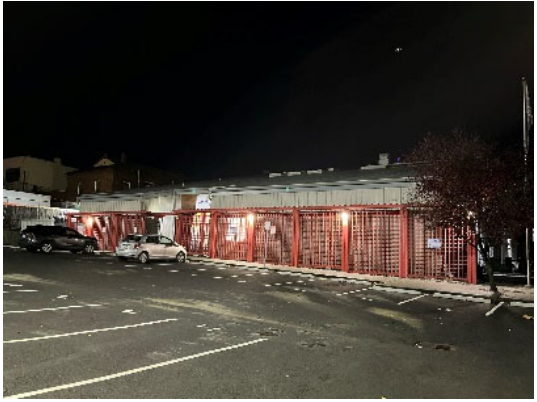
<p>King ST School</p>	<p>The school, with wall mounted sconces, has excellent presence and provides suitable light levels in the parking lot and surrounding sidewalk.</p>

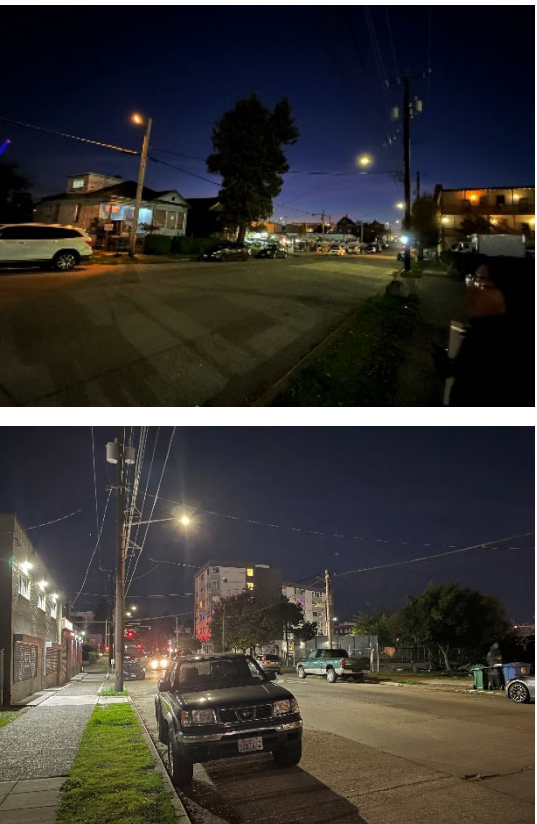
<p>King Street Lighting</p>	<p>King Street is not uniformly lit. Sidewalk lighting varies greatly, with some areas brightly lit by fixtures mounted to buildings or pole lights, and other areas dark, sometimes shadowed by trees. Low light levels make it hard to identify an approaching person.</p> <p>Additional “King” fixtures would be beneficial along the entire street in either a staggered or even configuration.</p>

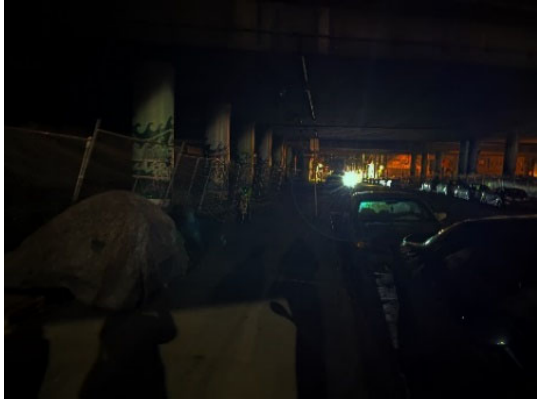
King Street under Freeway	<p>All the floodlights under the freeway are not on. The area is dark and extremely difficult for vehicle and facial recognition.</p> <p>Lights mounted to the freeway are WSDOT purview, though perhaps maintained by SPL.</p>

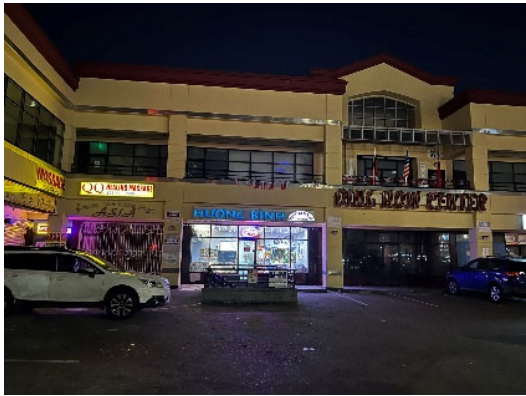
Ding How Center	<p>The center is lit from storefronts and roadway spill light. The area would benefit from additional lighting as well as having the “Ding How Center” sign lit.</p>

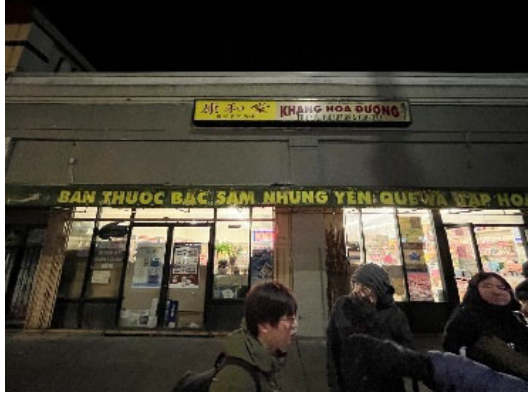
Khang Hoa Duong Store	<p>The interior lighting of the store contributes very little light for the sidewalk due to the covered window. Barbara Biondo noted that the store could remove their window coverings to allow for views in and out. This would help light the sidewalk. Unlit signage would benefit from being turned on / fixing if not working.</p>

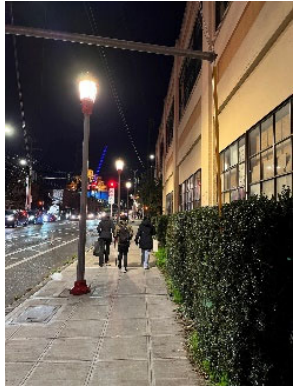
12 th Ave and Weller	<p>The sidewalk of 12th Ave is not uniformly lit. The west side of the street has multiple king fixtures which are located very close together.</p> <p>The east side has very few light fixtures.</p>

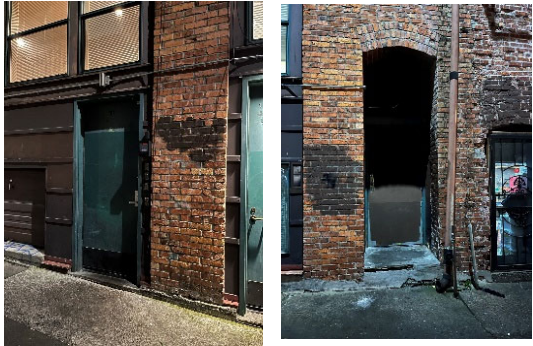
<p>Maynard Valley</p>	<p>The alley, overall, is decently lit. The light level is suitable for facial recognition and wayfinding. Some downlights in entry vestibules and wall lights over doors are not working.</p> <p>One of the up/down light wall sconces, that SparkLab (specified by SparkLab), has an uplight component that failed. The fixture is still under warranty and should be repaired or replaced.</p>

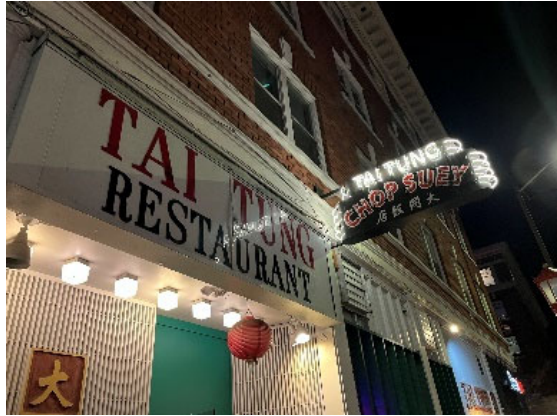
<p>Tai Tung Restaurant</p>	<p>The Tai Tung Restaurant entry fixtures provide good lighting for the street.</p> <p>The newly refurbished neon sign has one section that is not turned on / or has failed.</p>

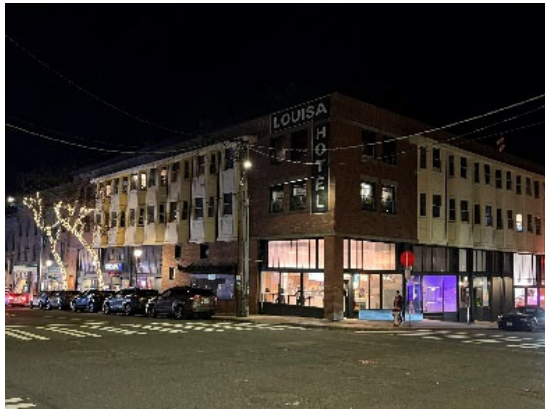
<p>Louisa Hotel</p>	<p>The Louisa Hotel's Boba place contributes greatly to the street lighting.</p> <p>The façade of the hotel is dark and could use some façade lighting or illumination of the large sign.</p>

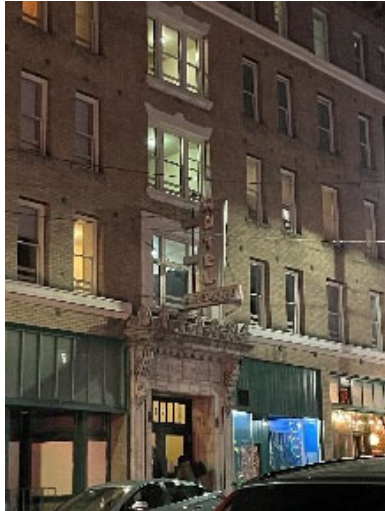
Hotel Milwaukee	This historic hotel signage would benefit from repair.

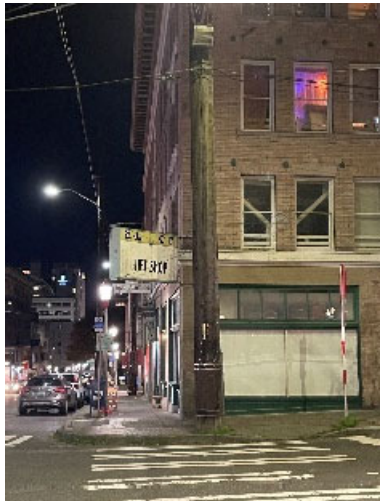
A closed shop	The “Gift Shop” sign would benefit from repair.

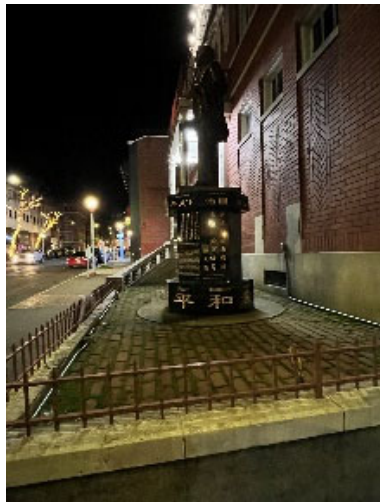
3.0	Feature Elements	
The Statue	Focused light fixtures for the statue should either be fixed or turned on.

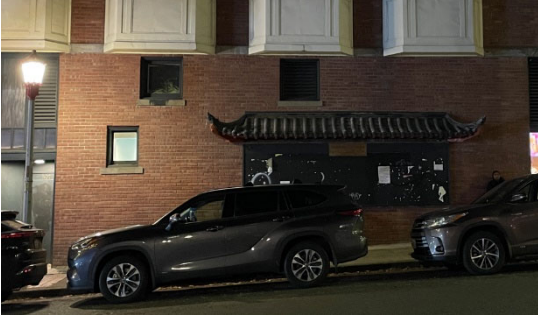
<p>Bulletin Board near Louisa Hotel</p>	<p>A potential neighborhood meeting point or identity-bringing destination, the ornate bulletin board awning would benefit from accent lighting.</p>

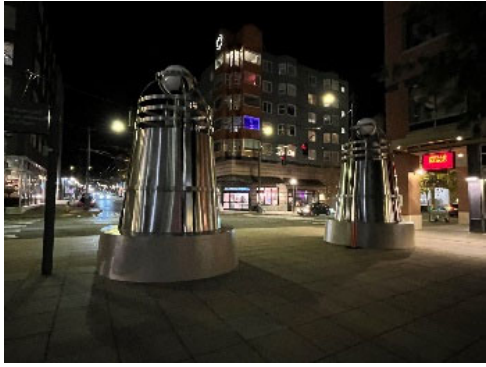
<p>Union Station</p>	<p>Two globe lights on decorative columns are turned off or have failed.</p>

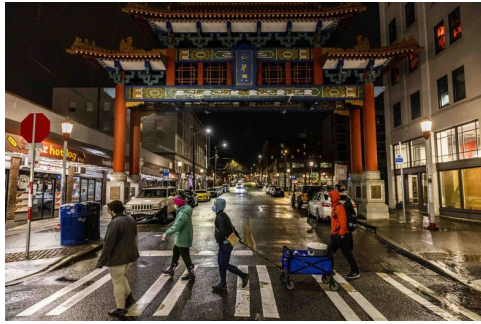
<p>China Town Grand Gate</p>	<p>The light for the Chinatown gate is barely adequate. The gate would benefit from additional fixtures and improved / warmer color temperature, black (not white) fixtures.</p>

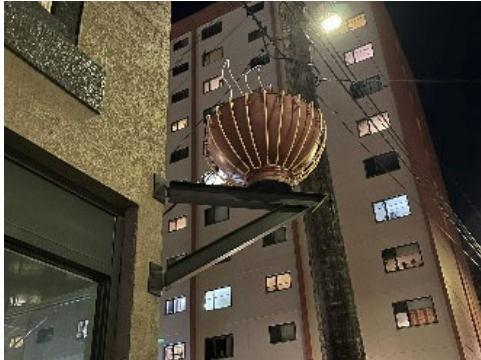
<p>Noodle Bowl</p>	<p>The distinctive, historic noodle bowl neon would benefit from refurbishment.</p>

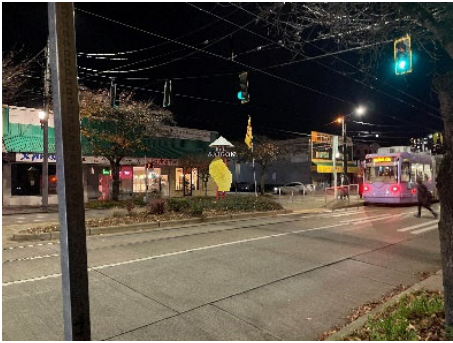
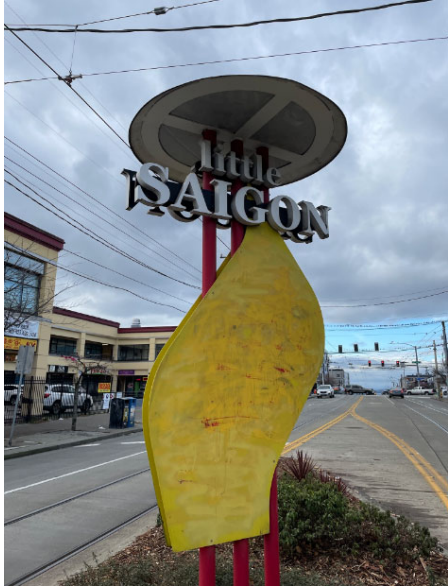
<p>Little Saigon Feature</p>	<p>This feature sculpture/sign would benefit from a higher output source under the cap.</p> <p>Investigation of the fixture shows that there is lighting integrated into the cap behind diffuse lenses. Source is likely not current technology.</p>
