GEOTECHNICAL REPORT
CANTON ALLEY AND NIHONMACHI ALLEY
IMPROVEMENTS
SEATTLE INTERNATIONAL DISTRICT
SEATTLE, WASHINGTON

Project No. 19-260
December 2019

Subject: **Geotechnical Report
Canton Alley and Nihonmachi Alley Improvements
Seattle International District, Seattle, Washington**

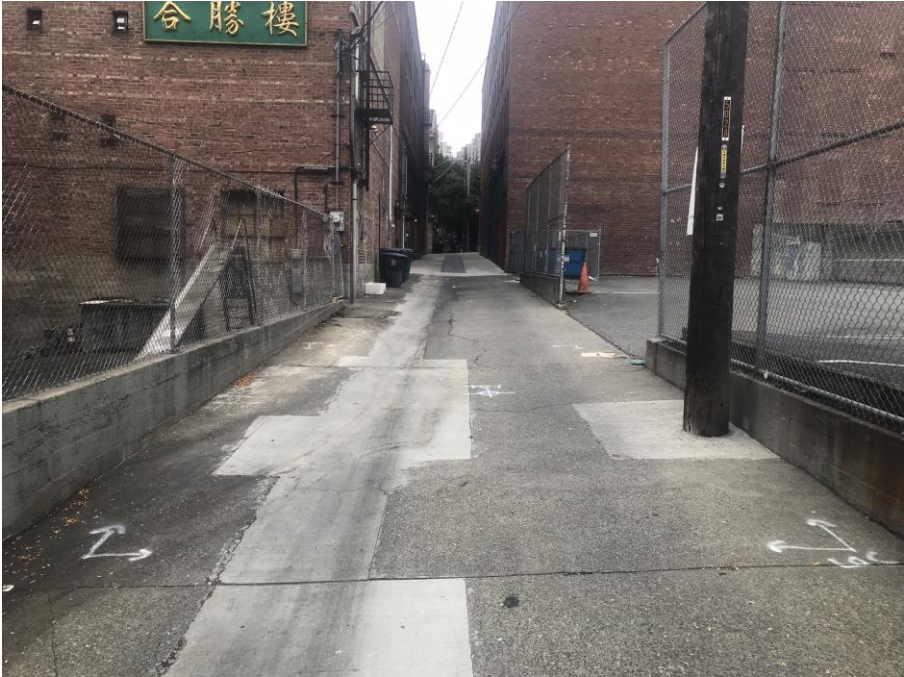
Plate 1. The southern portion of the Canton Alley, looking north from South Weller Street

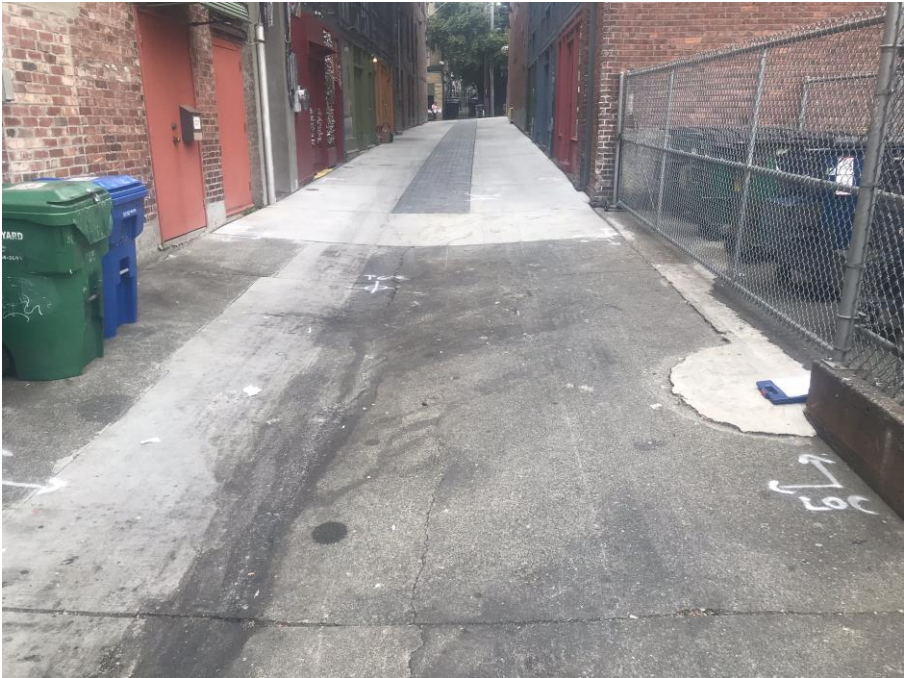
Plate 2. Middle and northern portions of the Canton Alley, looking north near Weller Street

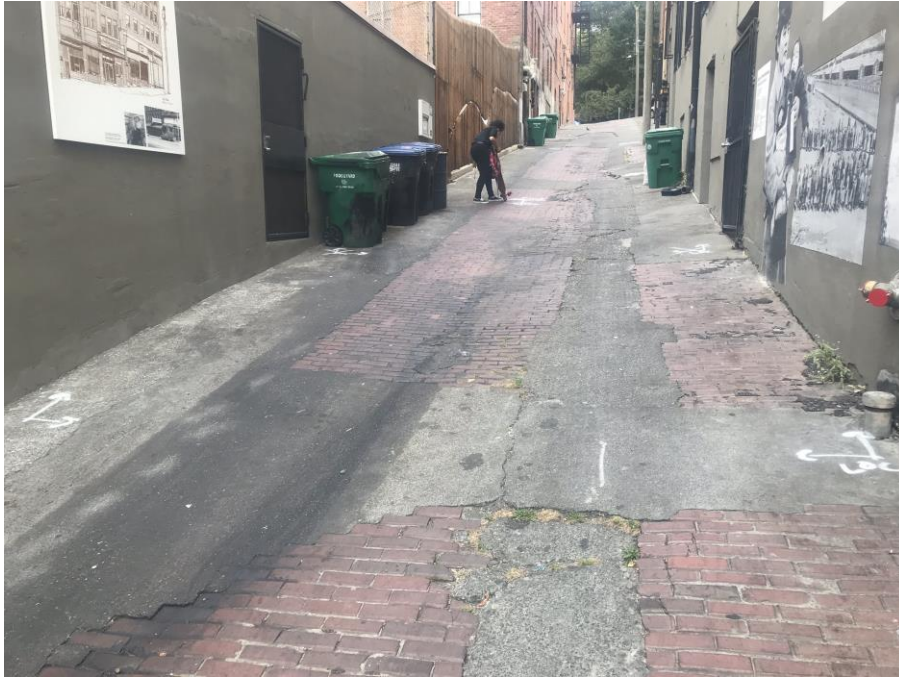
Plate 3. Southern portion of Nihonmachi Alley, looking north just north of South Jackson Street

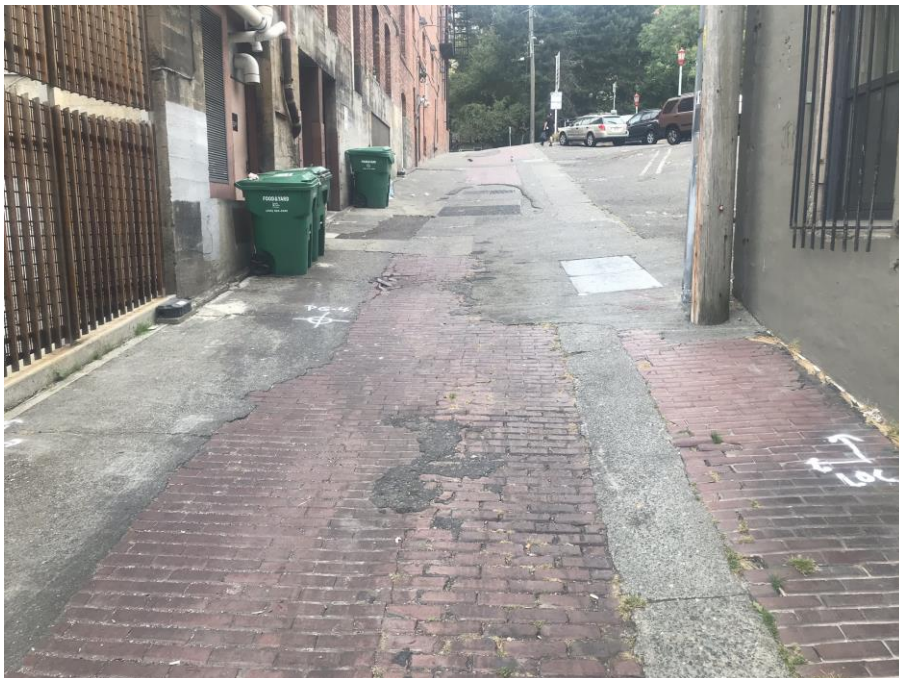
Plate 4. Middle portion of Nihonmachi Alley, looking north

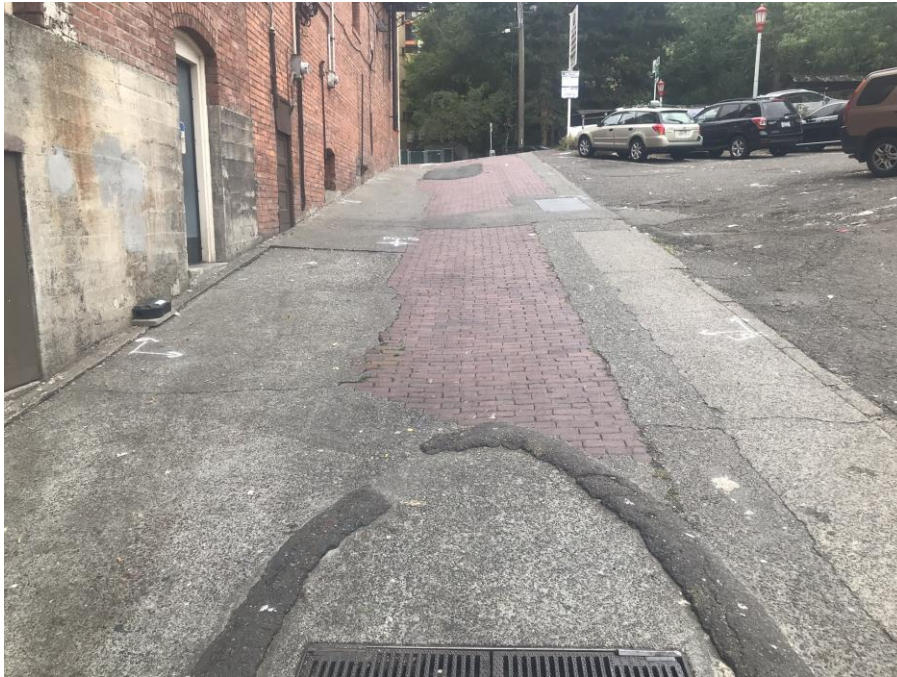
Plate 5. Northern portion of Nihonmachi Alley, looking north
