**INVITATION FOR BIDS**

**Hing Hay Park Restroom at the Bush  
Hotel (Phase I)**

1. Exhibit A: Restroom Phase I Renovation Plans
2. Exhibit B: 2019 Hazardous Material Survey performed by ECO Compliance Corporation

# BUSH HOTEL RESTROOM

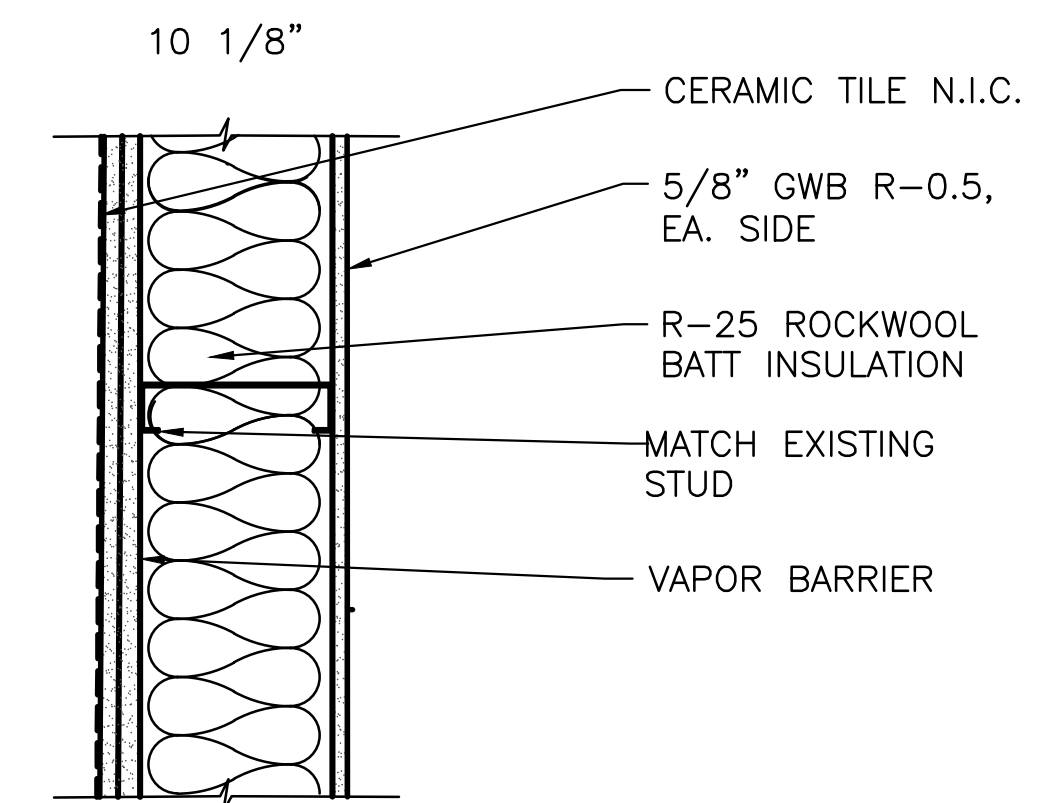
WALL TYPE SCHEDULE 3  
 SCALE: 1 1/2" = 1'- 0"

W-1 TOTAL R-VALUE: 26.03

TABLE C402.1.3 ENVELOPE INSULATION REQUIREMENTS  
 STEEL FRAMED WALLS: R-13 + R10ci  
 PROVIDED: R-26.03

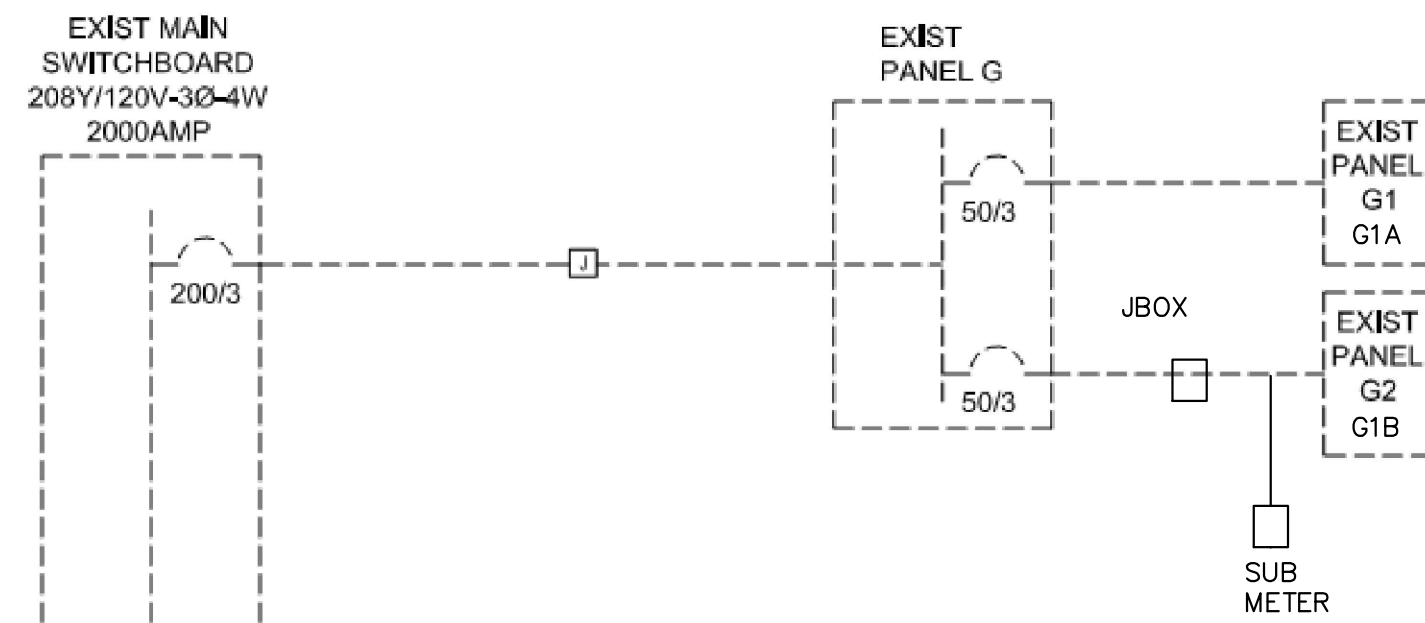
**1 PARTIAL ONE LINE DIAGARM**

EXISTING PANEL G1A  
MOUNTING: SURFACE  
AIC 10,000  
FED FROM MAIN DISCONNECT

VOLTS 208 / 120 3 PHASE, 4 WIRE, WYE  
AMPS 200  
MAIN CIRCUIT BEAKER GROUND BUS
